Deepwater Slough Restoration Monitoring: Channel Cross-section Comparisons, 2000 - 2006

W. Gregory Hood
Skagit River System Cooperative
LaConner, Washington

10 May 2006

Prepared for US Army Corps of Engineers, Seattle District

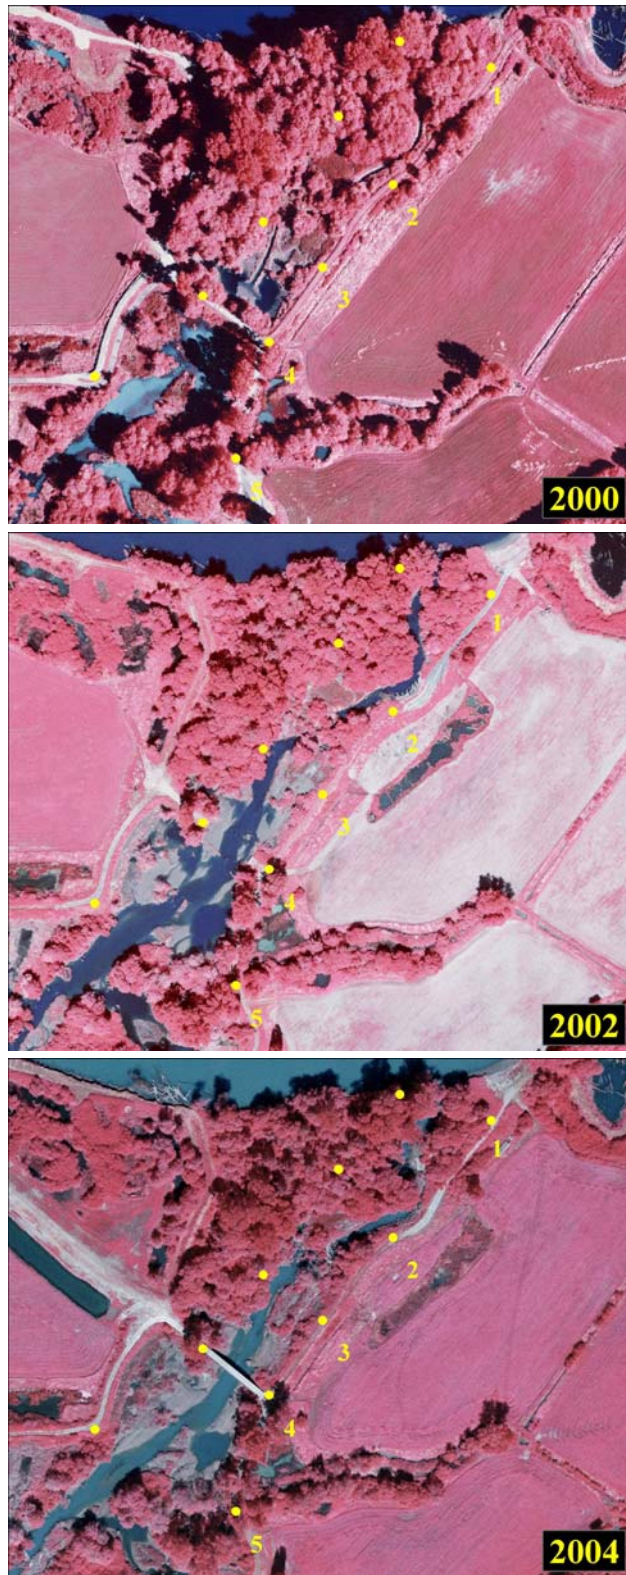
Planform changes along the Deepwater Slough distributary have occurred almost exclusively at the upstream end of the channel (Fig. 2). Downstream areas, in contrast, have experienced minor planform change. Upstream planform changes from 2002 to 2004 are difficult to discern precisely because forest canopy obscures much of the channel bank and channel. A canopy gap exposes some river water to aerial view and this gap has been widening from 2002 to 2004, indicating channel bank erosion and recruitment of riparian trees to LWD (large woody debris). The 2004 aerial photos and field observations indicate that much of this new LWD lies within the channel. The most significant geomorphic change occurred following the October 2003 flood, which carved a second channel (an avulsion) that diverges from Deepwater slough approximately 70m from its inlet and rejoins the channel approximately 105m downstream. The downstream portion of this new channel is revealed in the air photos by a gap in the forest canopy between transects 2 and 3.

Additionally, Freshwater Slough (the principal distributary of the South Fork Skagit River) is eroding near the inlet of Deepwater Slough. The river bank retreated by approximately 3m between 2002 and 2004. Likewise there has been significant bank erosion approximately 200m downstream along Freshwater Slough, that is threatening the integrity of the WDFW dikes protecting property currently managed for agricultural field-based waterfowl hunting. (WDFW has built set-back dikes in anticipation of dike failure.) Both of these erosional areas are located on the same cut-bank of a large bend in Freshwater Slough. The location of the Deepwater Slough inlet on a rapidly eroding cut-bank suggests that this inlet is exposed to high erosive energies and that further channel erosion is likely along both Freshwater and Deepwater Sloughs.

Figure 2. Planform comparisons of the dynamic upstream portion of Deepwater Slough. Cross-section transect start and end points are denoted by numbers and dots respectively.
