JUVENILE SALMON, ESTUARINE, AND FRESHWATER FISH UTILIZATION OF HABITAT ASSOCIATED WITH THE FISHER SLOUGH RESTORATION PROJECT IN 2011

Eric Beamer, Rich Henderson, and Karen Wolf
Skagit River System Cooperative

March 2013

Prepared for:
The Nature Conservancy (contract # WA-S-120216-062-0)

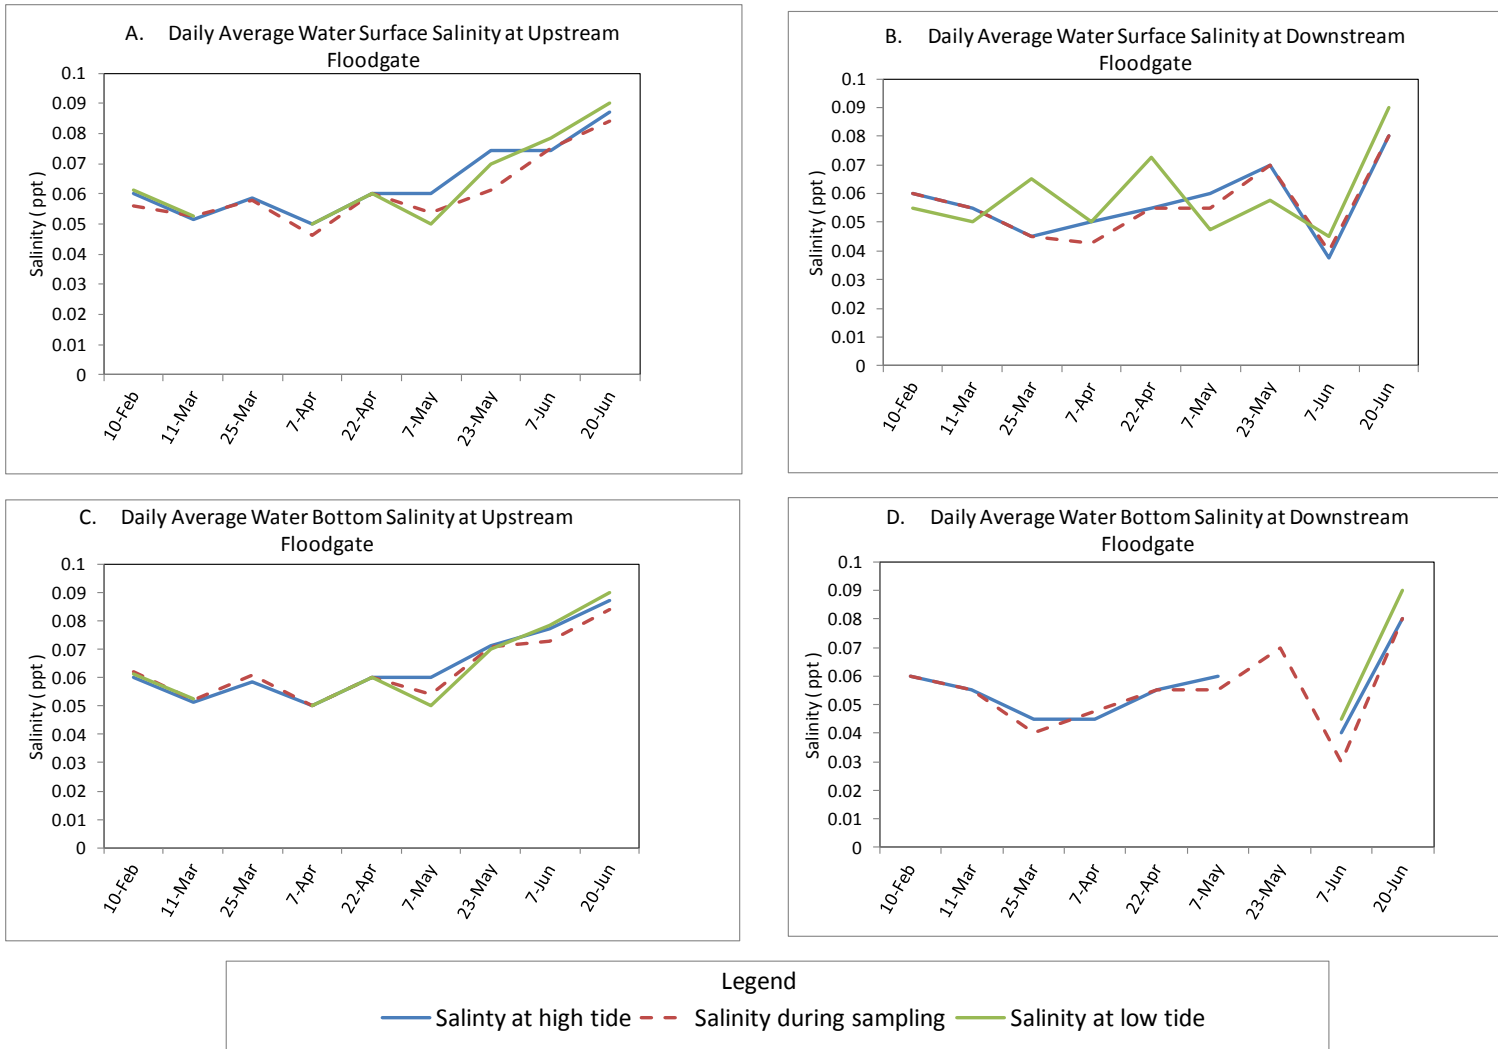
Figure 5. Comparison of daily average water surface and bottom salinity in parts per thousand for combined upstream and combined downstream sites by sampling day and tidal strata at Fisher Slough in 2011. The downstream floodgate sites do not include Tom Moore SI Upper Area. Measurements were not taken at the bottom of the water column when the depth was less than 0.30 meters.

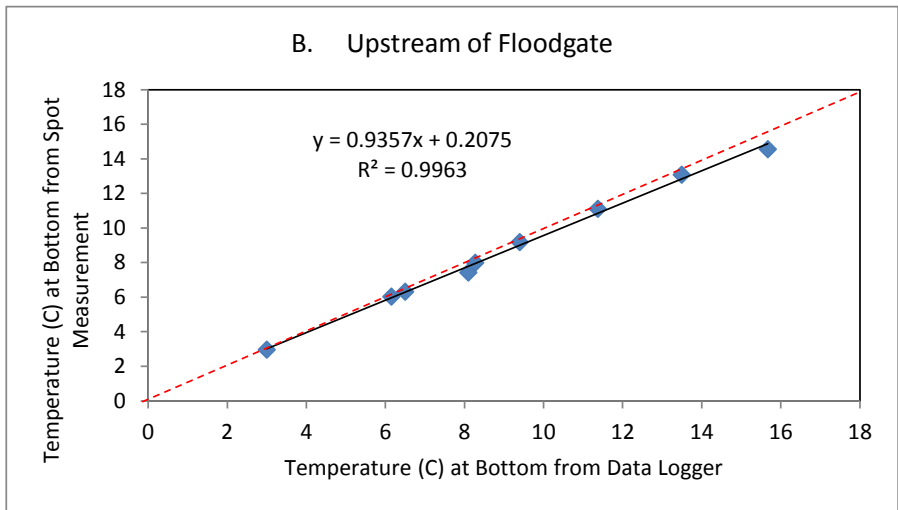
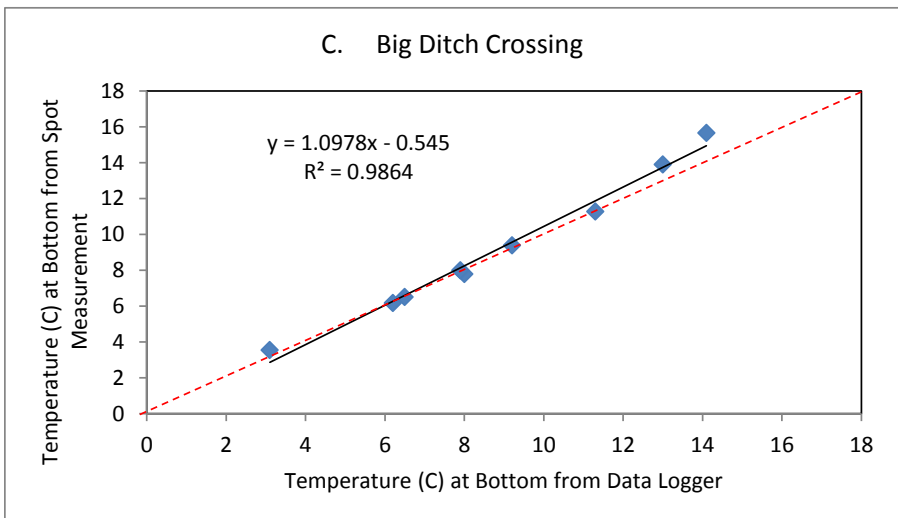
Figure 6. Comparison of water temperature from continuously reading data loggers (shown on x axis) and spot measurements taken during the time of beach seining in Fisher Slough, 2011 (shown on y axis). The 1:1 line is shown as a dashed line in each figure.

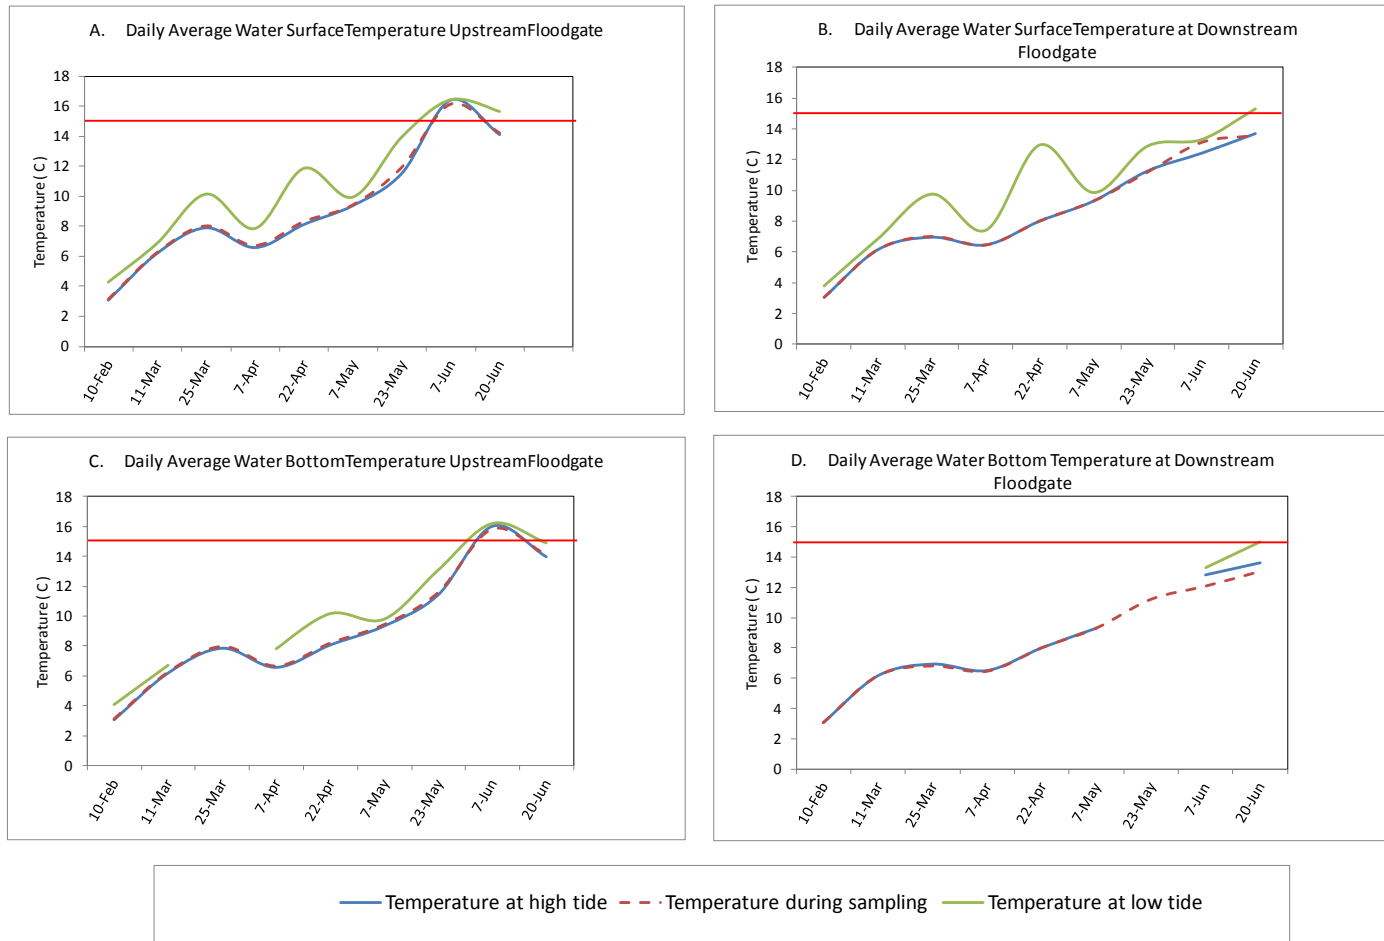
Figure 11. Comparison of daily average surface and bottom water temperature in degrees Celsius for combined upstream and combined downstream sites by sampling strata and day at Fisher Slough in 2011. The downstream sites do not include Tom Moore Sl Upper Area. Horizontal line at 15 °C shows the temperature postulated as stressful to juvenile Chinook salmon in estuaries (Fresh 2006). Measurements were not taken when the depth was less than 0.30 meters, hence the disconnected lines in panels C and D.

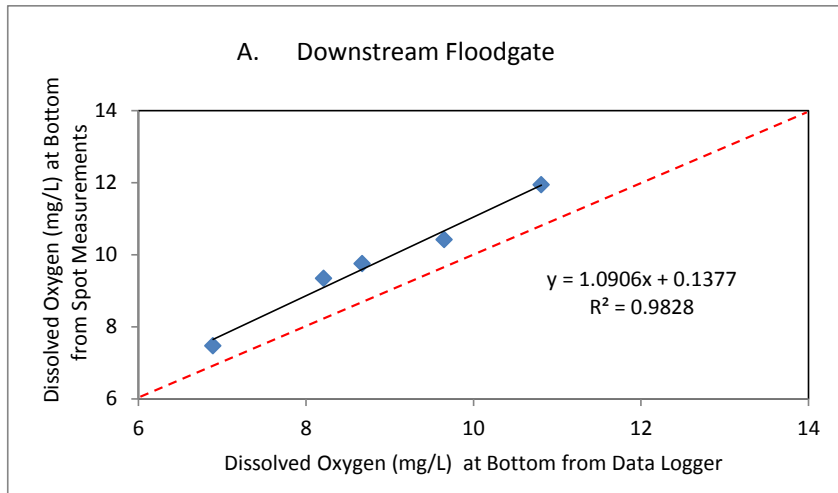
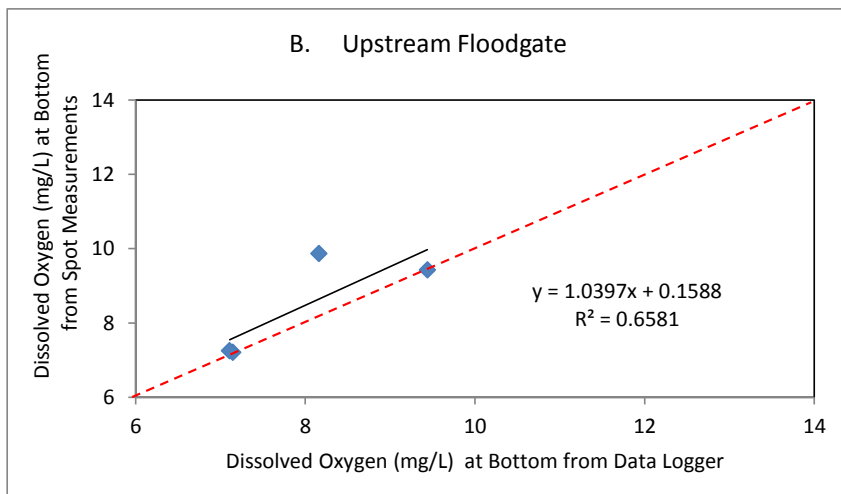
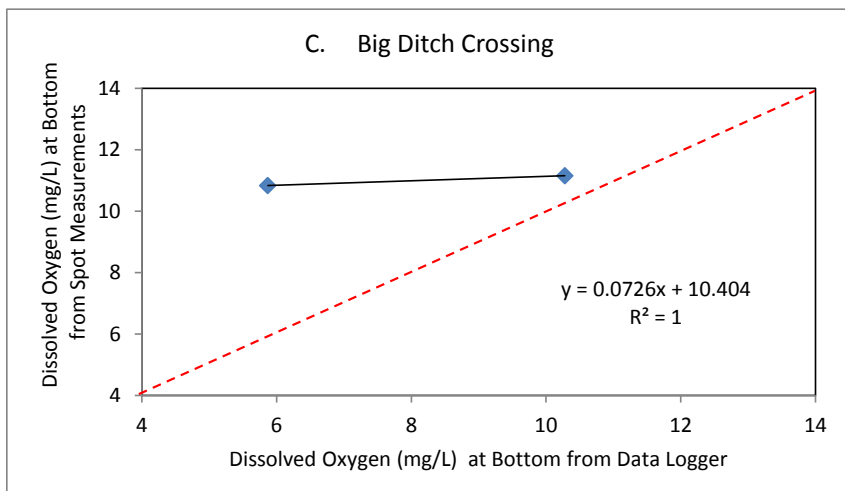
Figure 12. Comparison of dissolved oxygen levels from continuously reading data loggers (shown on x axis) and spot measurements taken during the time of beach seining in Fisher Slough, 2011 (shown on y axis). The 1:1 line is shown as a dashed line in each figure. In Panel C there are only two comparisons due to a data recording malfunction from the logger being surrounded by pond weed vegetation after May 9, 2011. Also note the different axis in Panel C.

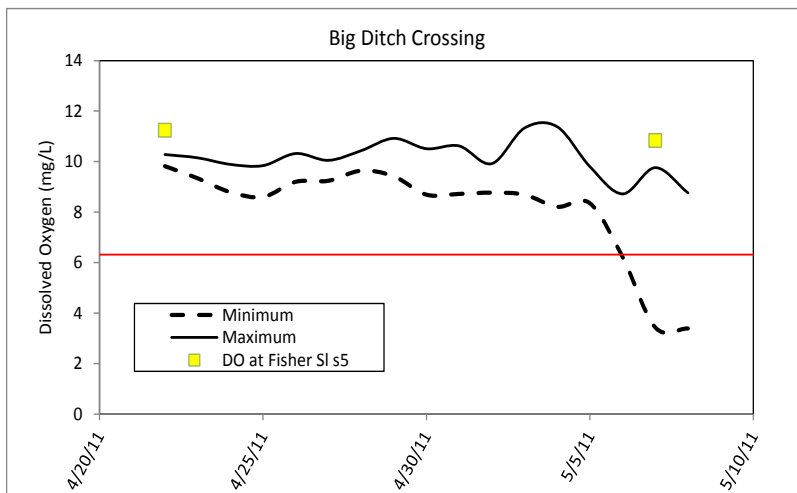
Figure 15. Maximum and minimum from DO data logger at Big Ditch Crossing and daily average bottom dissolved oxygen from spot measurements at site Fisher SI s5. Horizontal line at 6.5 mg/L is the water quality standard in Washington State for DO levels for DO levels in waters with salmonid rearing and migration. The Aquistar DO logger became buried by pond weed on May 9, resulting in inaccurate data after that time.

Figures 13-15 show that our spot measurements of DO generally reflect the high daily DO values from the continuously-measuring DO data loggers. Dissolved oxygen was measured at high and low tides on the days of fish sampling in order to determine how our measurements of DO during fish sampling compared with DO levels at tidal extremes on the same day. DO levels at high and low tides generally tracked with DO levels taken during fish sampling for both surface and bottom water column readings (Figure 18). Dissolved oxygen results from data loggers during June (when daily fluctuations in DO were most extreme) visually correlate with tidal cycles rather than day/night cycles (Figure 19).

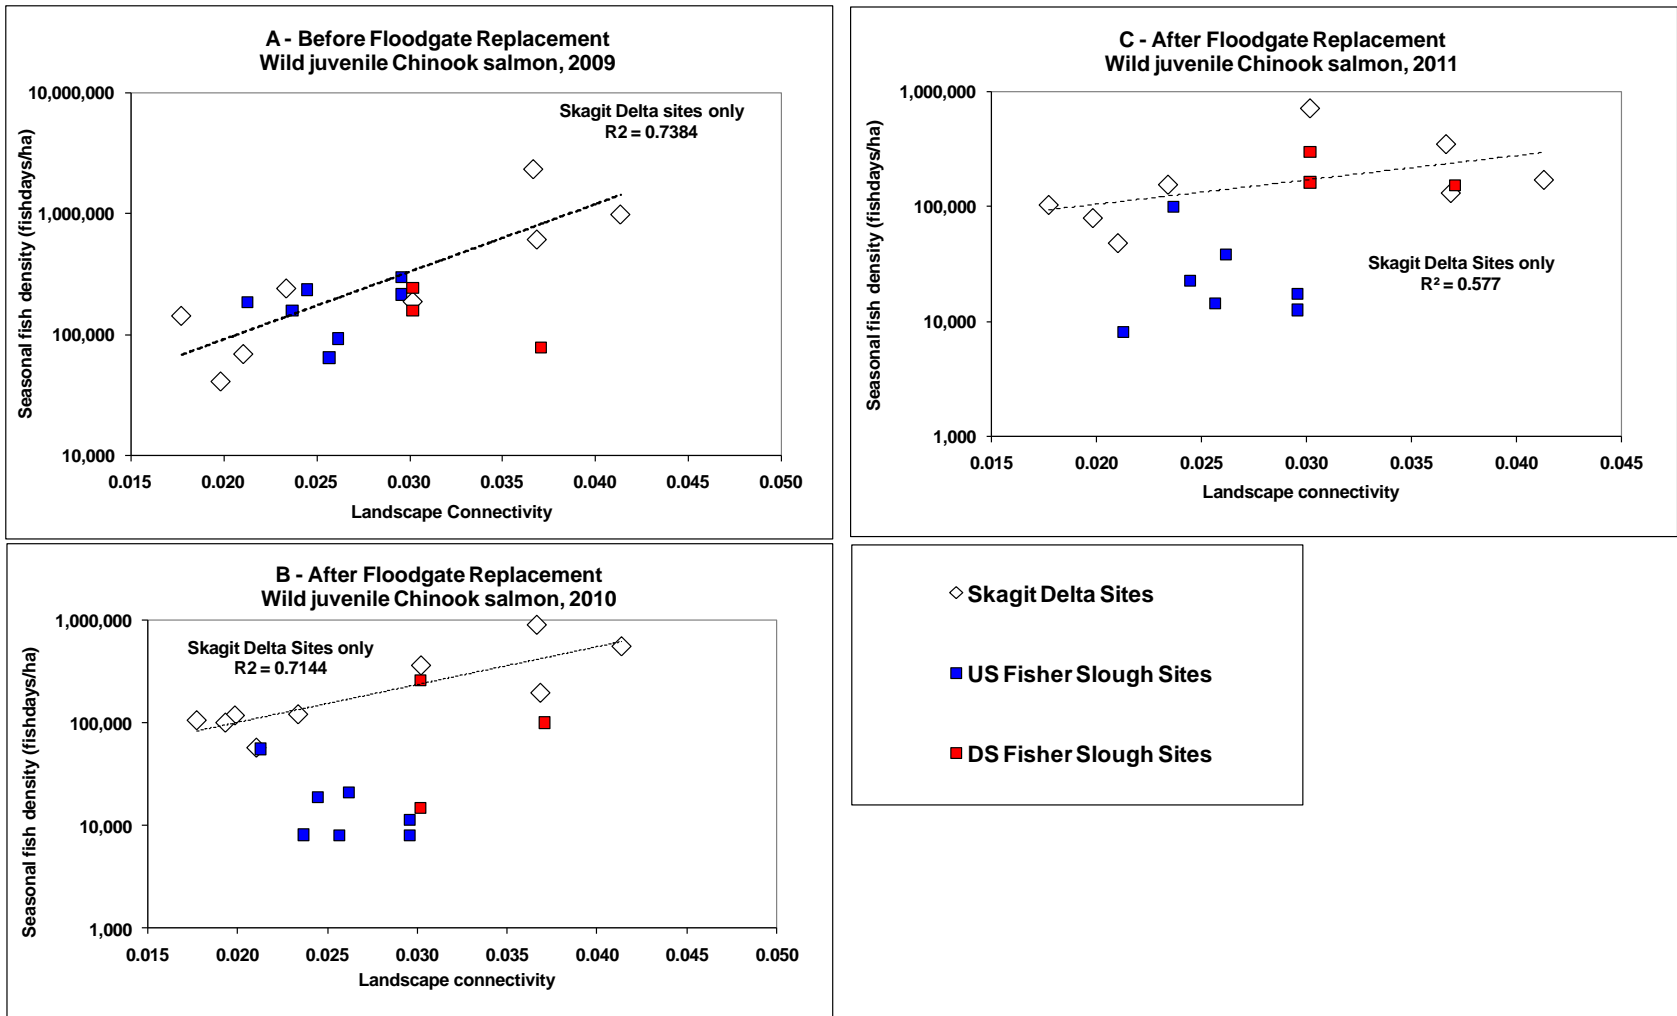
Figure 24. Relationship between landscape connectivity and seasonal Chinook salmon density for Skagit River delta long-term monitoring sites and Fisher Slough monitoring sites in 2009 through 2011. All panels show connectivity calculated to Fisher Slough sites based on fish migration pathways using the downstream end of Tom Moore Slough. Panel A shows results for 2009 (before floodgate replacement). Panel B shows results for 2010 (year 1 after floodgate replacement). Panel C shows results for 2011 (year 2 after floodgate replacement).

There is a strong positive relationship between seasonal wild juvenile Chinook salmon density and landscape connectivity for the long term monitoring sites throughout the Skagit River delta for each of the three years when Fisher Slough monitoring has occurred (Figure 24). Depending on the year, landscape connectivity explains 58% to 74% of the variation in seasonal juvenile Chinook salmon density at Skagit River delta long-term monitoring sites. Before floodgate replacement (year 2009) the Fisher Slough monitoring sites generally clustered within the scatter of the Skagit River long term monitoring sites (Figure 24, panel A). In both years after floodgate replacement, most Fisher Slough sites upstream of the floodgate fell outside (lower) of the scatter of the Skagit River long term monitoring sites (Figure 24, panels B and C). In contrast, the Fisher Slough sites located downstream of the floodgate are clustered within the scatter of the Skagit River long term monitoring sites.

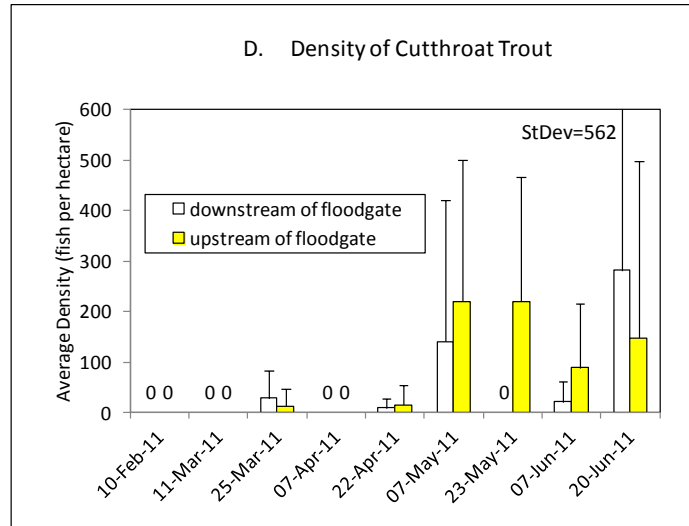
Figure 26. Comparison of the average density of coho salmon, chum salmon and cutthroat trout for combined upstream and combined downstream sites by sampling day at Fisher Slough in 2011. Error bars are one standard deviation. Note the different scales on the y axis.

Yearling coho salmon were present in Fisher Slough upstream of the floodgate starting on March 25 with an average density of 15 fish per hectare (Figure 26, panel A). The density increased as the coho salmon smolt outmigration continued, with an average peak density of 490 fish per hectare seen on May 23. Yearling coho salmon were not found upstream of the floodgate on the last sampling date of June 20.

Yearling coho salmon were only found on May 7 and June 7 at the sites downstream of the floodgate. The peak density was 6,101 fish per hectare on May 7, while the density was 141 fish per hectare on June 7 (Figure 26, panel A).

Subyearling coho salmon were found starting on April 7 at the sites downstream of the floodgate. The peak density of 439 fish per hectare of area sampled was on April 22. During April there were more sub-yearling Coho at the sites downstream than upstream of the floodgate. After April, there were lower density levels at the downstream sites than at the upstream sites through our last sampling event of June 20 (Figure 26, panel B).

Juvenile chum salmon were observed at Fisher Slough in 2011 primarily downstream of the floodgate. The peak density of chum salmon at the sites downstream of the floodgate was on April 7 with an average of 1,639 fish per hectare (Figure 26, panel C). Upstream of the floodgate, chum salmon were only caught on April 7 with an average of 15 fish per hectare of area sampled. Juvenile chum salmon were caught on 3% of sets made upstream of the floodgate and 31% of sets made downstream of the floodgate suggests that juvenile chum salmon were not progeny from adult chum salmon that spawned in tributaries upstream of the floodgate. No chum salmon were caught at any site after May 23.
